# Manhole Inspection Summary

Manhole # S45GG\_012MH

**Inspection** ☐ Is Incomplete Rating: **3) Fair**

Insp Date: **8/14/08 12:38 PM**

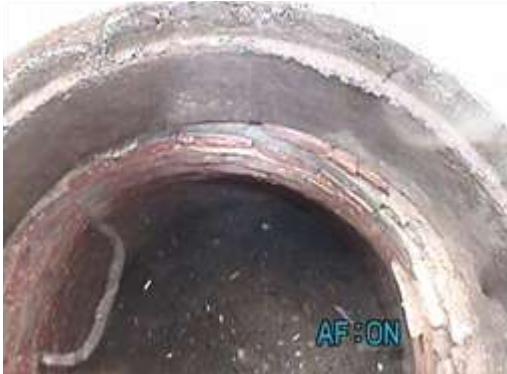
Defect 1

Infiltration: ☐ None ☐ Joint ☐ Cracks ☐ Mortar ☐ Roots ☒ **Wall**

Infiltration

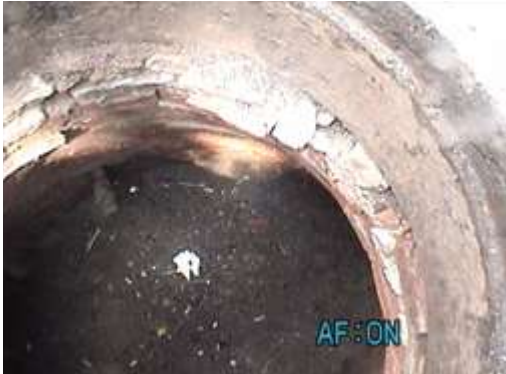
Defect 2

Condition: ☐ Sound ☐ Cracked ☐ Root Intrusion ☒ **Loose Brick** ☐ Deteriorated

Infiltration: ☐ None ☐ Joint ☐ Cracks ☒ **Mortar** ☐ Roots ☐ Wall

Loose brick

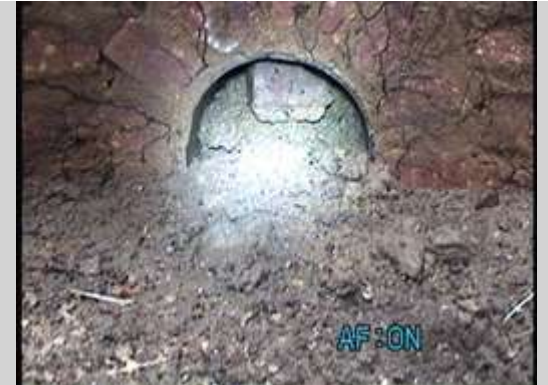
12 O'Clock Outflow

8 in. Circular Gravity Sewer  
Pipe Out @ 12 O'Clock

Deposits: ☐ None ☐ Mud ☐ Sludge ☒ **Debris** ☐ Grease

Silt Depth: **4** (in.) Deposits Extent: **Heavy**
